# Manhole Inspection Summary

Manhole # S41UU\_010MH

Insp Date: **9/3/08 1:19 PM**

**Location** Address: **1335 HOMESTEAD ST**

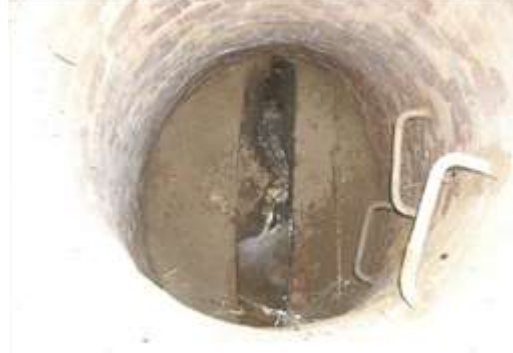
Top View

Evidence of surcharge - Bench debris.  
Channel debris.

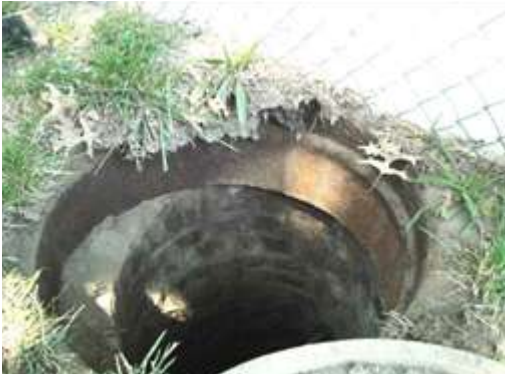
Defect

Frame offset. Corbel and Barrel  
infiltration.

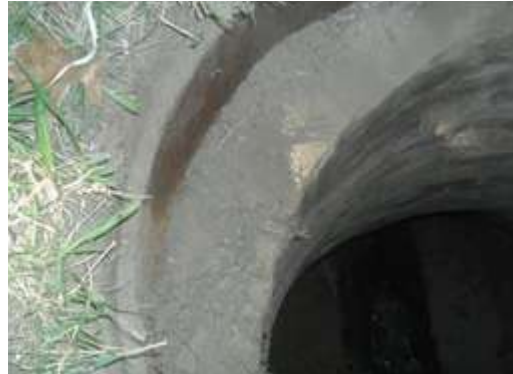
Defect

Frame leaks. Frame offset.

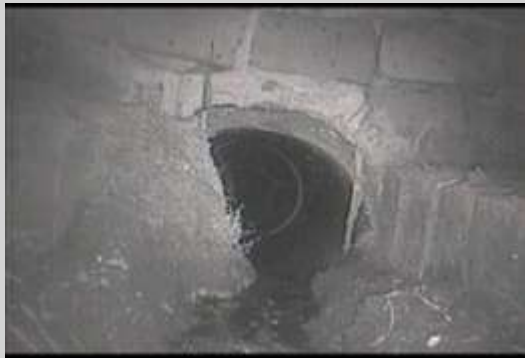
### 8 in. Circular Gravity Sewer Pipe Out @ 12 O'Clock

Channel root intrusion.

Deposits: ☐ None ☒ **Mud** ☐ Sludge ☒ **Debris** ☒ **Grease**

Silt Depth: **4** (in.) Deposits Extent: **Heavy**

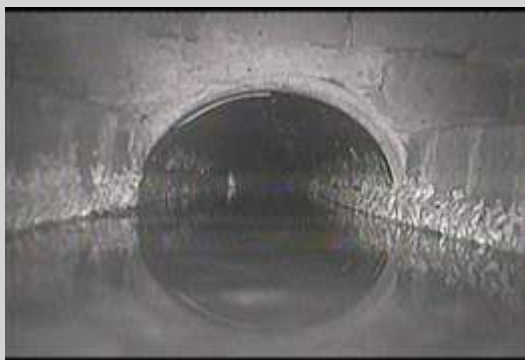
### 8 in. Circular Gravity Sewer Pipe In @ 6 O'Clock

Deposits: ☐ None ☐ Mud ☐ Sludge ☐ Debris ☒ **Grease**

Silt Depth: **1** (in.) Deposits Extent: **Light**
